**TENNESSEE VALLEY AUTHORITY - SEQUOYAH NUCLEAR PLANT (SQN)  
UNIT 2 - DOCKET NO. 50-328- FACILITY OPERATING LICENSE  
DPR 79 - LICENSEE EVENT REPORT (LER) 50-328/2002003**

Automatic Reactor Trip Resulting from a Generator Stator Cooling Water High Temperature Caused by a Raw Cooling Water Valve Failure

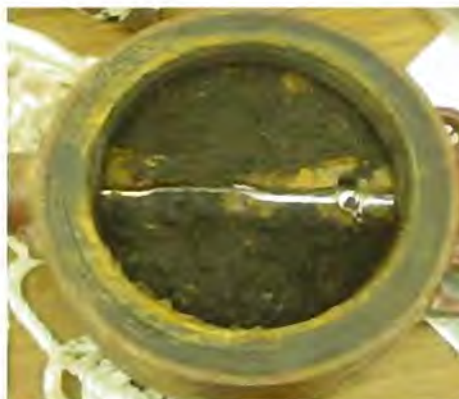
The root cause of the event was the loss of raw cooling water flow to the generator stator cooling water system resulting from a manual isolation supply valve to stator cooling water heat exchanger blocking flow due to internal damage. The valve disk was found split down the shaft.

A raw cooling water butterfly valve (Henry Pratt Model 2FII) failed. This valve is an 8-inch, hand wheel operated, valve, which is the raw cooling water inlet isolation valve to the Unit 2 stator cooling water heat exchanger. During restart activities following the refueling outage, Operations personnel tried to open the raw cooling water valve to the generator stator cooling water system. When the stem would not turn because the disk was bound into the seat, a supplemental force was used to force stem rotation.

The supplemental force caused the pre-existing crack in the valve disk to crack completely down the disk. Additional use of the supplemental force caused the shaft pin to rotate into the disk hole, splitting the disk apart and allowing flow through the center of the disk.

After the disk was pushed into the rubber seat far enough to add additional resistance to rotation, the shear key sheared and the valve operator turned freely to its stop. This gave the operators the impression that the valve was full open and the valve position indicator was reading incorrectly.

The raw cooling water valve was replaced.
